RECONNAISSANCE LEVEL CHARACTERIZATION REPORT (RLCR)

881 CLUSTER CLOSURE PROJECT (Buildings 881, 881F and 887, and Stacks 1, 2, and 3)

REVISION 0

November 6, 2001

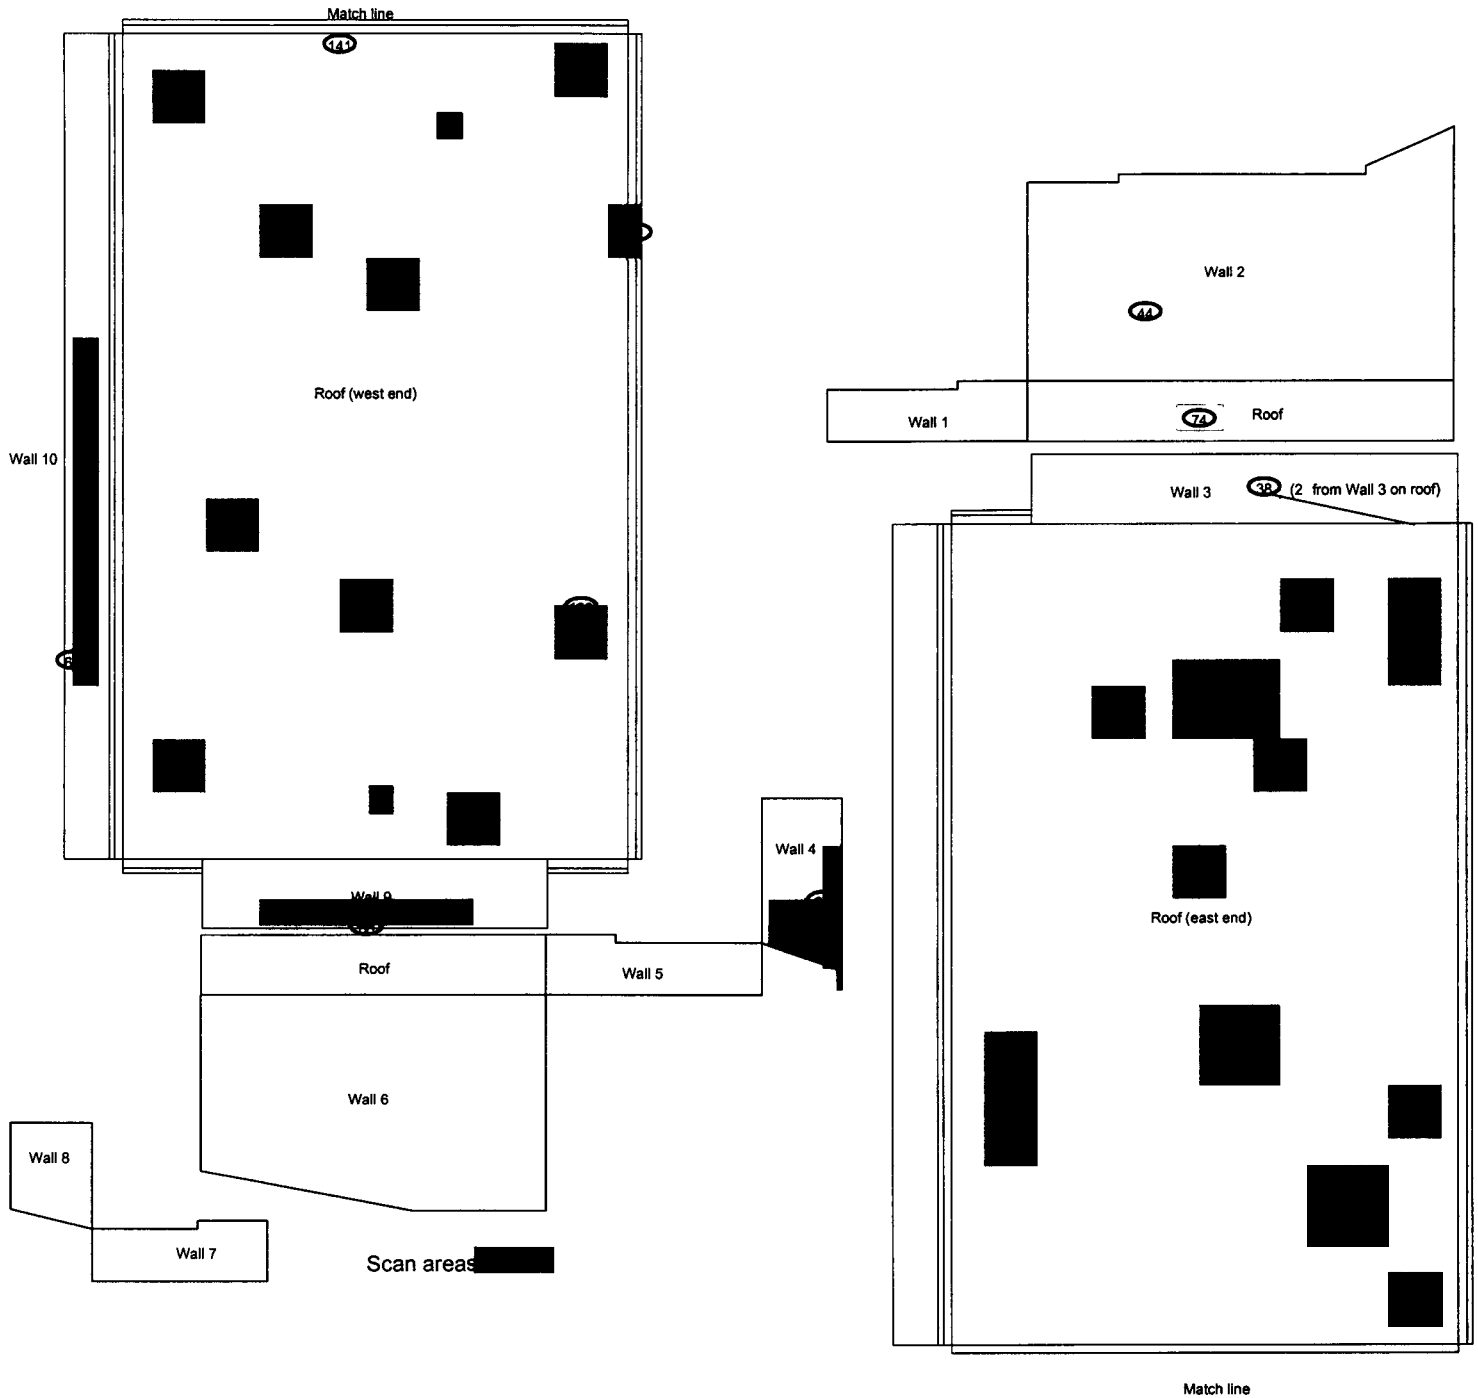
SURVEY UNIT - MAP 10 OF 11

Survey Area B Survey Unit 881-B-001 Classification 3
 Building 881
 Survey Unit Description Exterior South Roof and Walls
 Total Floor Area NA Total Area 10315 sq m Grid Size N/A
